## Fire Testing of Exterior Vents

*Indicative testing conducted in accordance with the test methodology described in ASTM E2886/E2886M, Standard Test Method for Evaluating the Ability of Exterior Vents to Resist the Entry of Embers and Direct Flame Impingement*

**Continuous Foundation Joto-Vent with Architectural Covering**

**WFCi Report #20034**

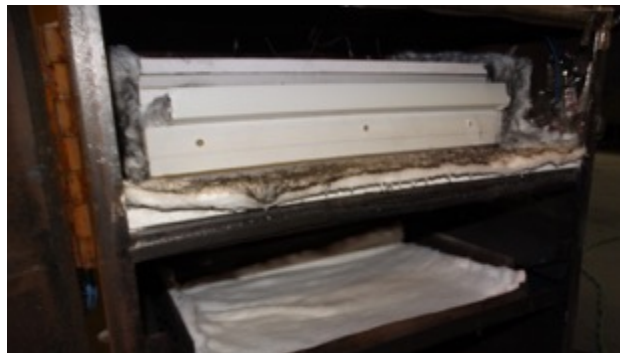
Figure 2. Actual installation of vent in ember chamber with upper and lower shelf.

Embers are generated from a circular tumbler filled with 10 Class C brand (ASTM E108) positioned over a representative installed exterior vent and combustible target material. The brands are ignited by a 2" gas flame for a 3 min period. After the brand ignition, the tumbler is activated allowing the created embers to fall on top of the vent (upper shelf). Embers that the vent does not collect/stop can pass through and ignite a combustible cotton target (lower shelf) below the vent. Air flow is regulated by a fan downstream of the tumbler, vent, and target material at a velocity of 2 mi/hr. The test is run until all the embers have run out of the tumbler and all combustion ceased. Assembly dimensions and locations are described in Figure 1 as well as the actual installation in Figure 2.

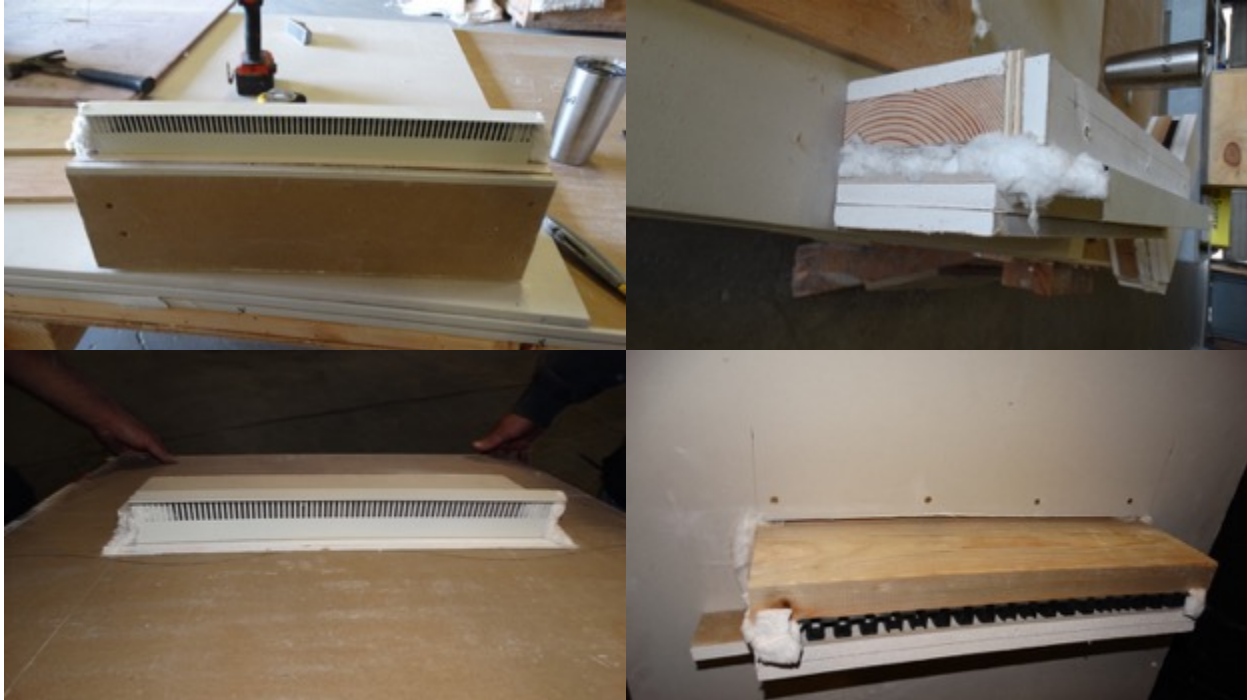
Figure 6. Representative samples showing (a) flashing gap for ember test, (b) side cross-section for ember test, (c) flashing gap for flame test, and (d) crawl-space side of vent system.

The Joto-vent and architectural covering were installed as proscribed by the manufacturer with essentially no gap between the bottom of the architectural covering and the foundation. Representative samples are shown in Figure 6. WFCi did not select the sample components and has not verified the manufacturing techniques or accuracy of the products and labeling (see chain of custody in ).

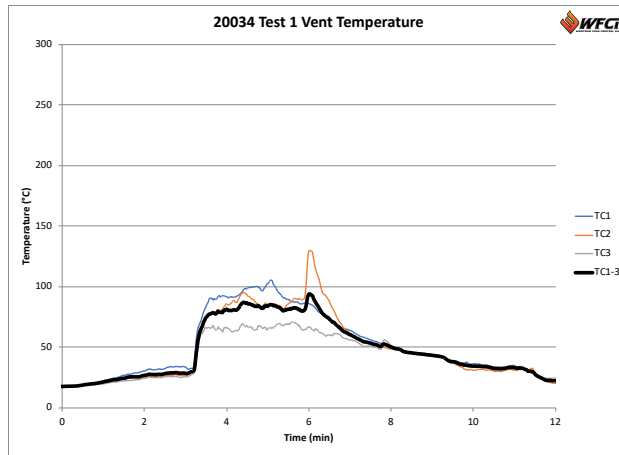
The three thermocouples just above the vent on the upper shelf showed an initial spike to around 90°C when the tumbler was activated which remained for approximately 3 min, then gradually decreased as the embers burned out.

Figure 8. Test 1 temperature just above vent.

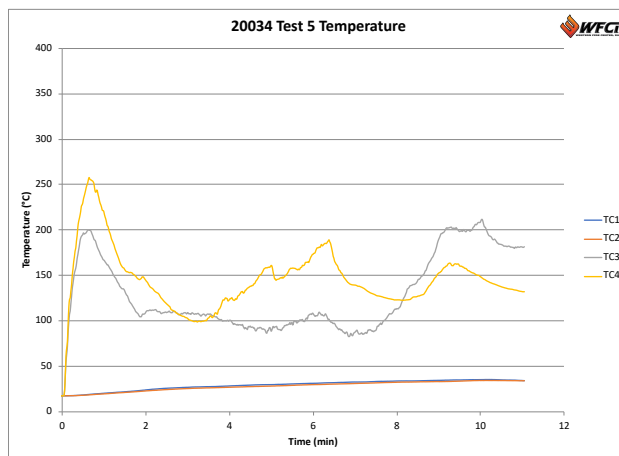
The four thermocouples installed on the unexposed vent showed an initial spike of near 250°C by one of the TCs, which oscillated for the remainder of the test. No TCs got above 350°C.

Figure 16. Test 5 temperature on unexposed side of vent.
